Subject: Smoky Canyon Mine Remedial Investigation/Feasibility Study
Dinwoody Material Source Investigation Report

To: Jeff Hamilton, Environmental Engineering Manager; Grant Williams, Senior Mine Engineer
From: Katie Wilkes, Geologist
Cc: Neil Musilek, Engineering Manager; Casey McCaslin, Survey
Date: November 27, 2018
Re: **Dinwoody Material Source Investigation Report**

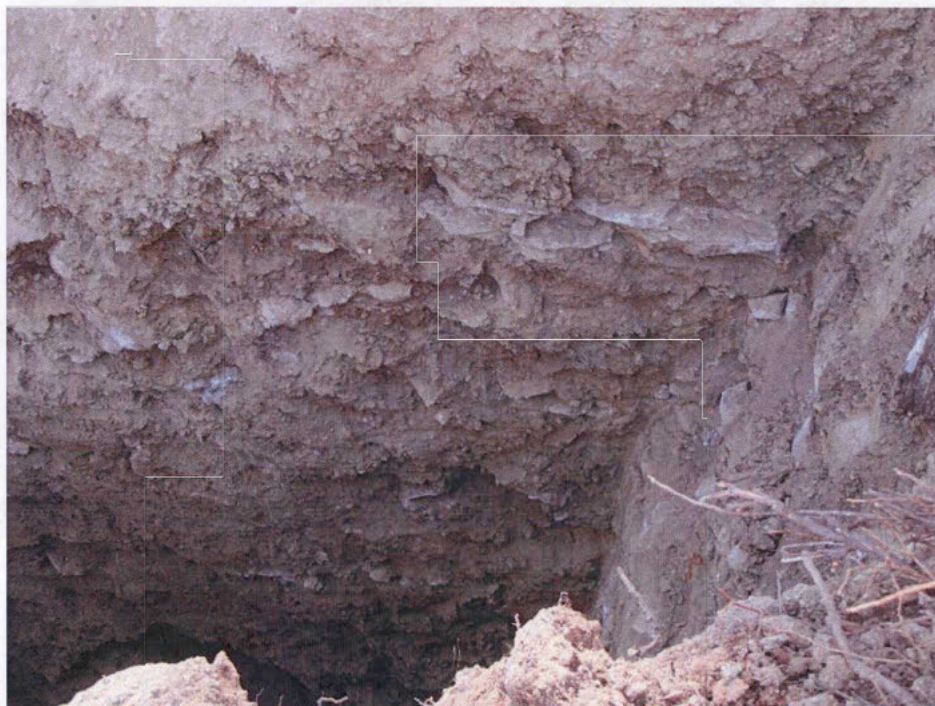
DW_DA02

All sites were terminated at refusal of digging and ripper teeth were broken on the rock at sites DA01 and DA03. Although none of the excavation sites indicated good quality Dinwoody cover material, road cuts were considered in evaluation of the site as a whole. Additional field notes for the D-Panel borrow areas and excavation sites are in the trench logs attachment. A general observation in the steep D and E panel areas is that there is more cliff forming rock with elevation up the slope. **Figure 3** indicates the areas of the original D-Borrow designs and the adaptations following examination from this field program. Selected images for each site are included in this report and additional photo documentation is available within the attachments.

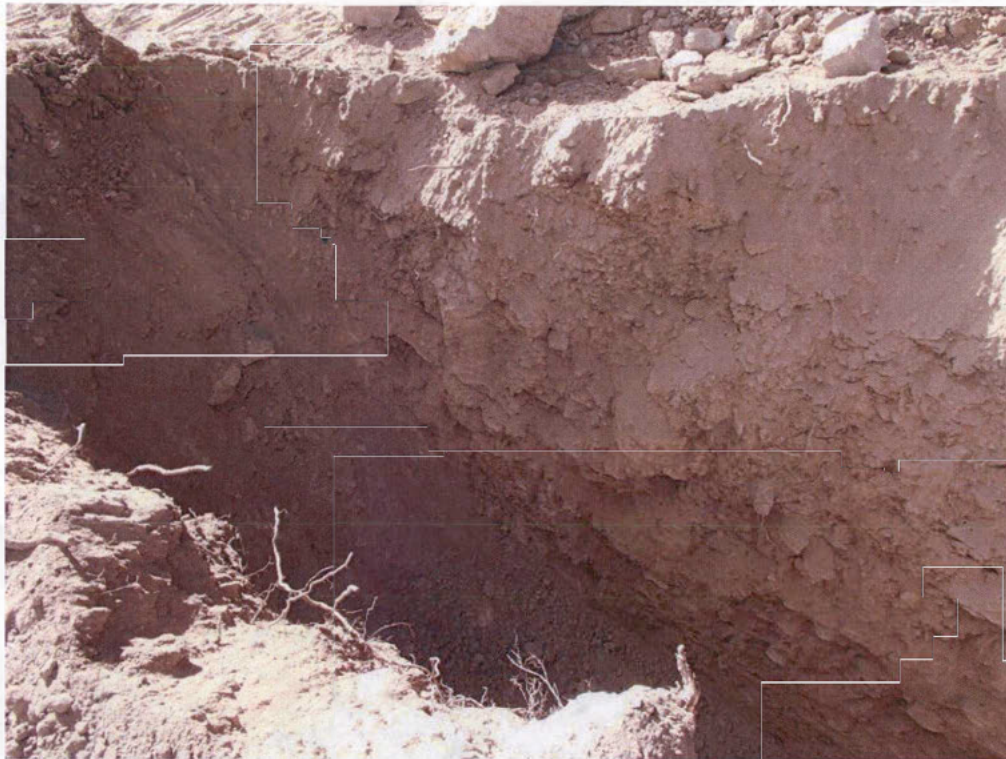
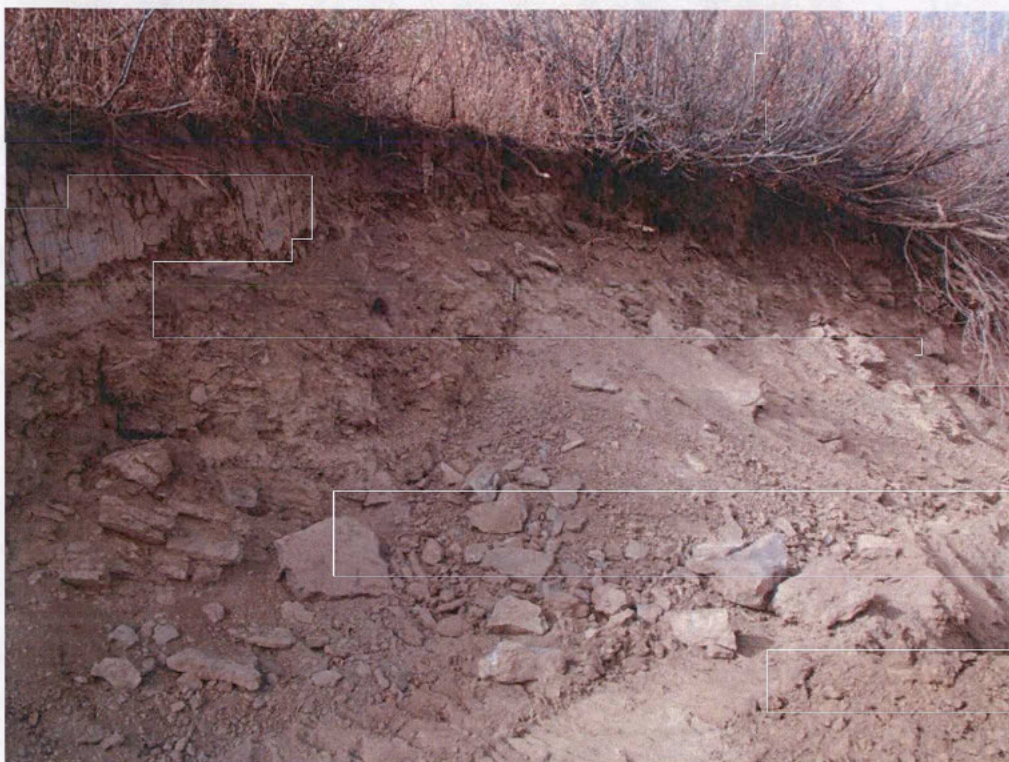
DW_EA02

All sites were terminated at refusal of digging through rock. EA01 and EB02 were completed nearly at the surface. None of the excavation sites indicated a large quantity of good cover-quality Dinwoody. Alternating rock and loose material in some locations saw better digging below the surface rock outcrops although none of the trenches were extended to the reach of the equipment before refusal. The upslope extent for accumulation of usable, weathered Dinwoody appears to coincide with the areas of existing borrows in both D and E panel. Additional field notes for the E-Panel borrow excavation sites are in the trench logs attachment.
